May 15, 2018

Re: Kahn Pedestrian Bridge –Structural Follow up Report
Graham Ave.
Metuchen, NJ 08840
MC Project No. MET-294

Structural Observations

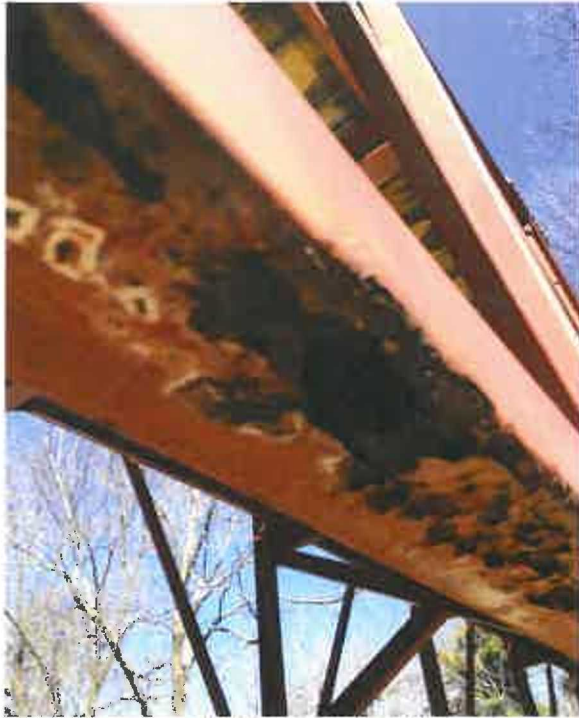
Upon sound testing the bottom chord of the East stringer with a hammer, our office observed that the tube steel bottom chord of the stringer is rusting on the inside (see photos #1, #2 and #3). This condition was observed at multiple locations along the stringer's length. Some interior rusted areas that were exposed by sound testing included locations that still had paint on their exterior face and no visible rust on the outside. At the center splice connection of this stringer's bottom chord, our office observed severe rust and deterioration in the stringer members, splice plates and splice plate bolts (see photo #4). At the splice, it also appears that the ends of the bottom stringer chords do not have a closure plate. This has left the tube steel chord open to water infiltration.

(Photo #1) East Stringer: Rust on Underside of Bottom Chord

Based on this additional investigation and findings on the East stringer, our previous evaluation noted in our 2/2/18 report needs to be modified. It is our recommendation that the bridge should be completely taken down as soon as possible and replaced with a new bridge.

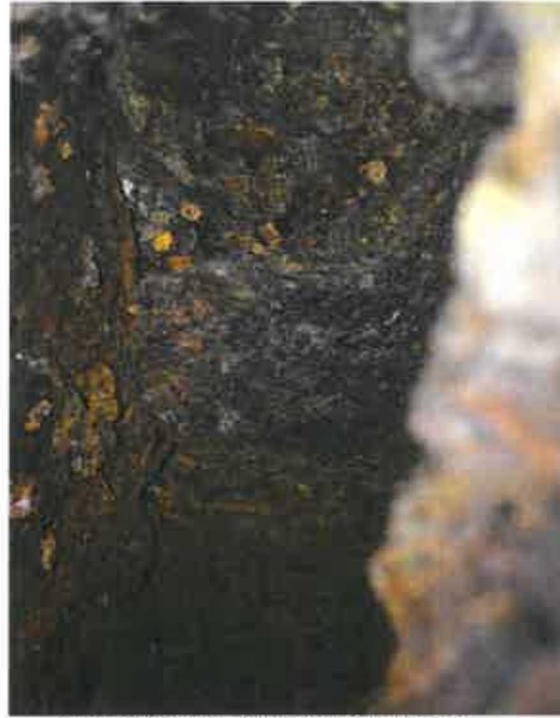
(Photo #2) East Stringer: Rust on Interior of Bottom Chord

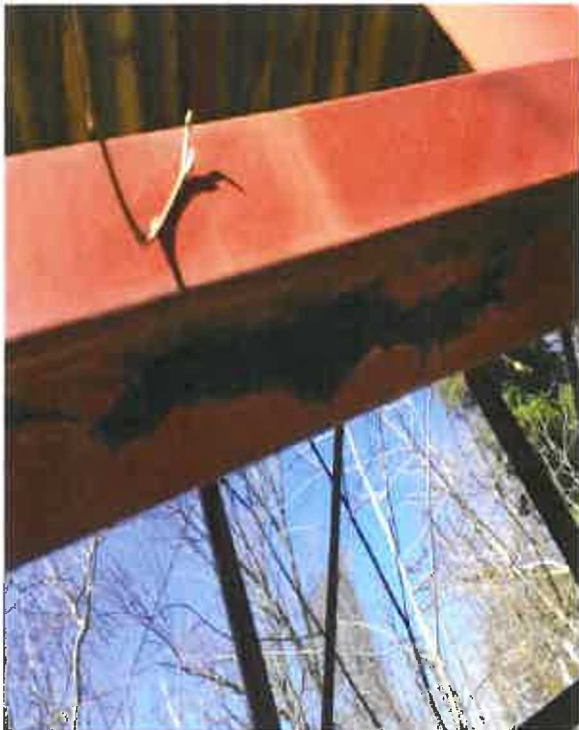
(Photo #3) East Stringer: Rust on Underside of Bottom Chord

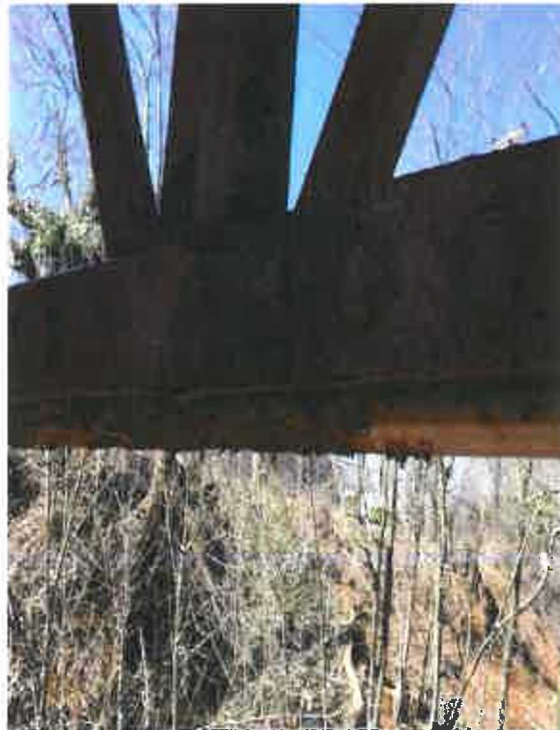
(Photo #4) East Stringer: Rust at Splice Connection

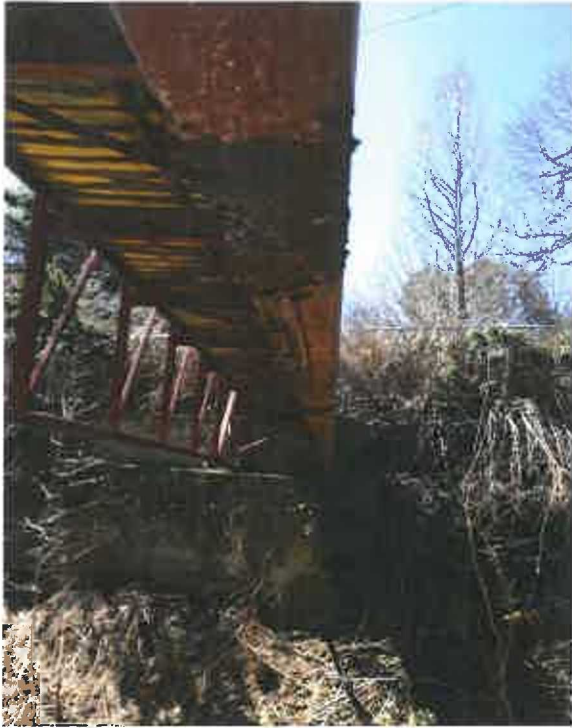
The South half of the West stringer's bottom chord has visible rust and deterioration (see photos #5 and #6). But upon sound testing those areas with a hammer, the rust at this stringer appears to be on the exterior and not on the interior like the other stringer. The condition of the center splice connection of this stringer's bottom chord has the same deterioration as the East stringer (see photo #7). In addition, at this splice, no end closure plates were observed at these tube steel chords either.

(Photo #5) West Stringer: Rust on Bottom Chord

Based on our further observations, the rust in the West stringer and underside of walkway steel support framing could be addressed by scraping the rust, repainting the steel and providing new

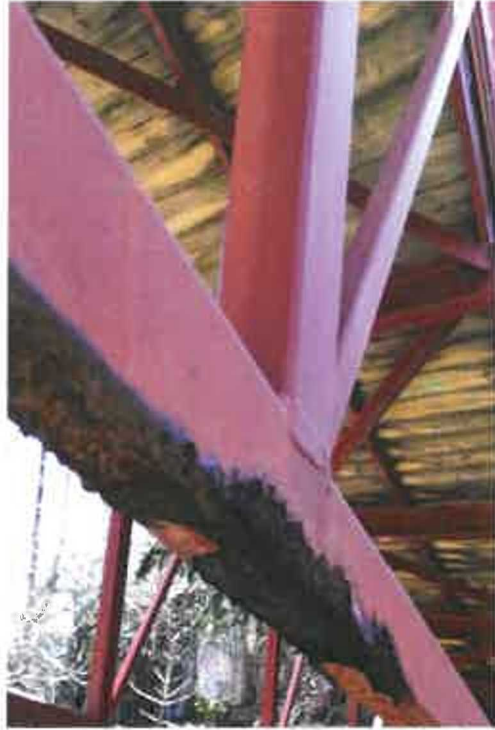
(Photo #6) West Stringer: Rust on Bottom Chord

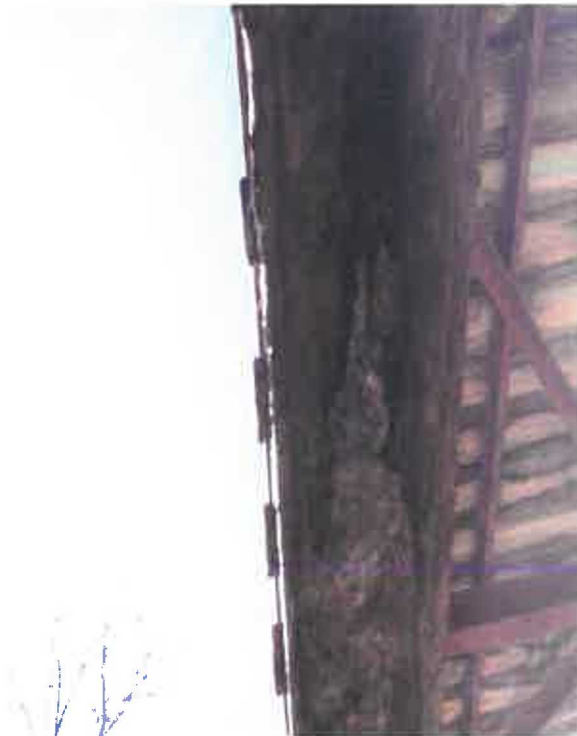
(Photo #7) West Stringer: Rust at Splice Connection

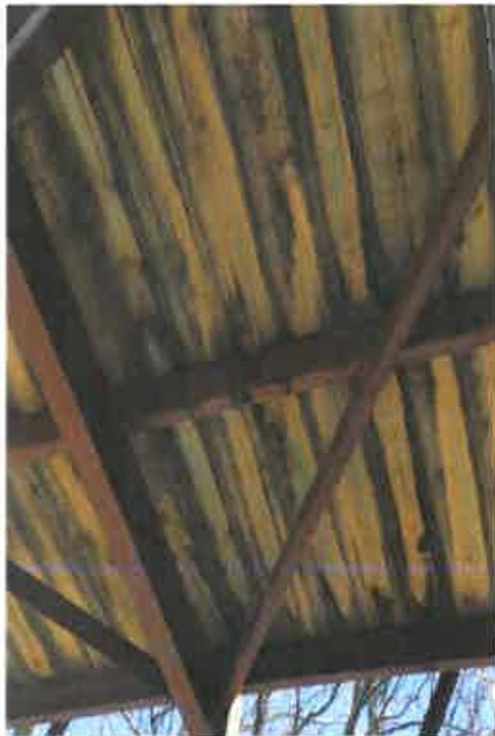
Our office also observed areas of surface rust in the steel framing supporting the underside of the timber walkway planks (see photo #8). While not of an immediate concern, this rusting needs to be addressed by scraping the deteriorated areas and repainting the steel.

(Photo #8) Rust at Underside of Plank Support Steel
